**National Highway  
Traffic Safety  
Administration**

Case Vehicle (A): 2000 Ford  
 Type: Taurus SE, 4-door sedan  
 Driver: 18-year-old male  
 CDC: 01-RFEW-3

# ACCIDENT SCHEMATIC

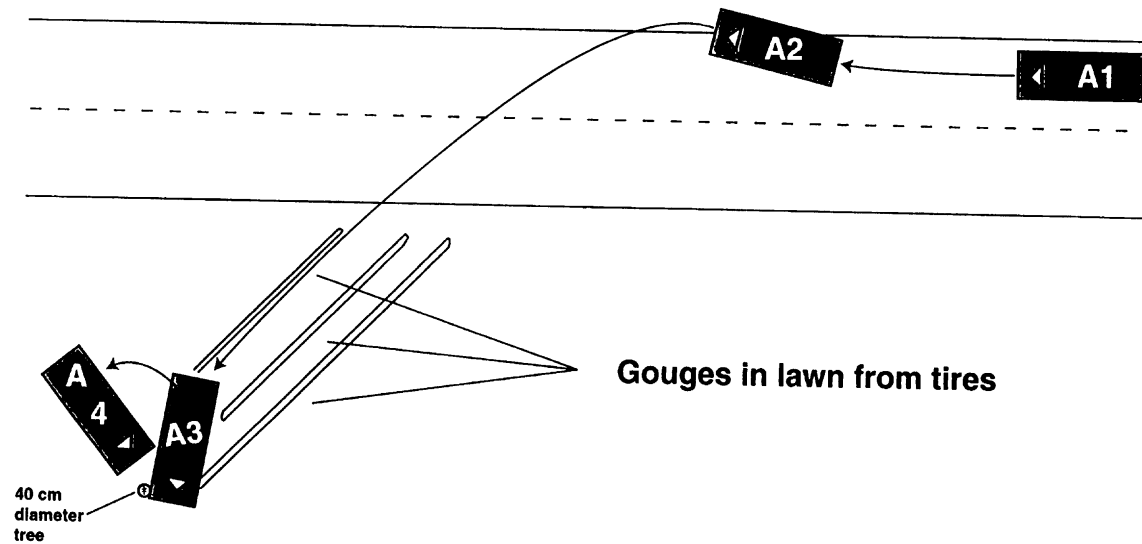
G-14

ACCIDENT DESCRIPTION: Case vehicle (A) was traveling south  
and the right wheels went off the west edge of  
the road surface. Case vehicle (A) then veered left  
went across the road, went into a yaw and struck a tree with its  
right-front.

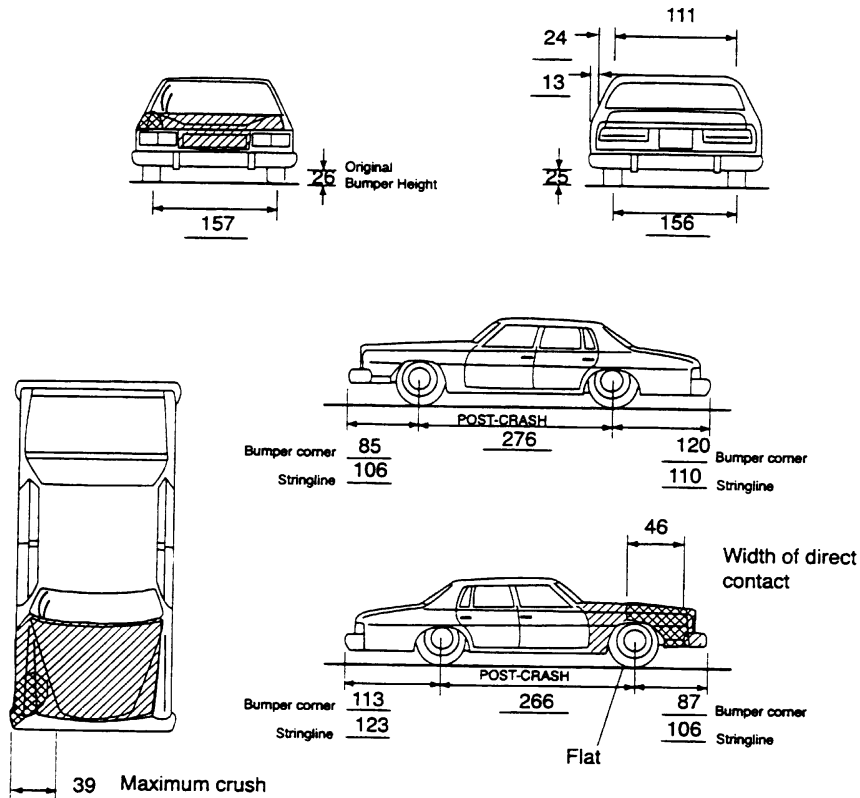
## VEHICLE DAMAGE

(Slide 6) Damage to case vehicle (A) was moderate. (Slide 7) Direct damage began 12-cm rearward of the right-front bumper corner and extended 46 cm to the rear. The maximum crush was 39 cm at a point inboard of the right-front wheel.

Using the WinSMASH accident-reconstruction program, and a (slides 8, 9, 10 and 11) crush profile measured for case vehicle (A), the following impact severity was calculated:

Specific Impact No.	Location of Direct Damage	Location of Field L
1	12 cm rear of rt ft BC	12 cm rear of rt ft BC

Specific Impact Number	Plane of Impact C-Measur.	Direct Damage		Field L	C <sub>1</sub>	C <sub>2</sub>	C <sub>3</sub>	C <sub>4</sub>	C <sub>5</sub>	C <sub>6</sub>	±D
		Length (DDL)	Max Crush								
1	4	46	39	60	0	39	38	31	25	0	+154
1	4	046	039	060	000	039	038	031	025	000	+154
13	14	15 16 17	18 19 20	21 22 23	24 25 26	27 28 29	30 31 32	33 34 35	36 37 38	39 40 41	42 43 44 45
2

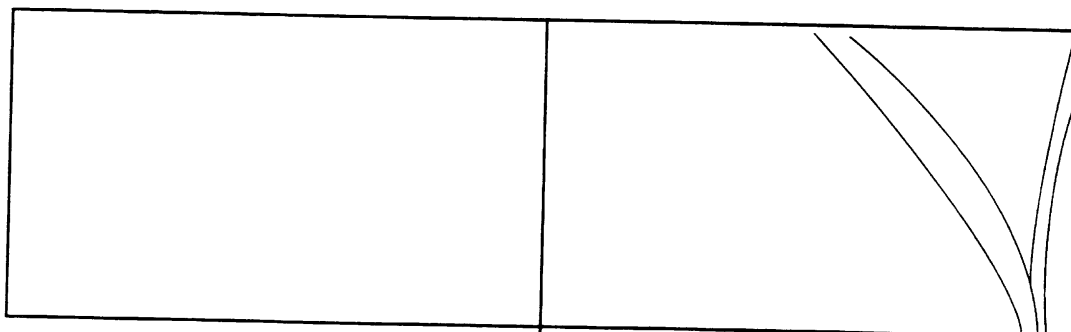
In the front, (slide 15) the right headlight assembly, the hood, (slide 16) the right portion of the engine compartment, and (slides 17 and 18) both hood hinges were damaged. (Slide 19) The rear edge of the hood was elevated but it did not contact the windshield. (Slide 20) Rescue or towing personnel damaged the hood latch when they opened the hood to disconnect the battery. (Slide 21) The right portion of the windshield was cracked due to deformation of the cowl.

Windshield cracked due to cowl contact

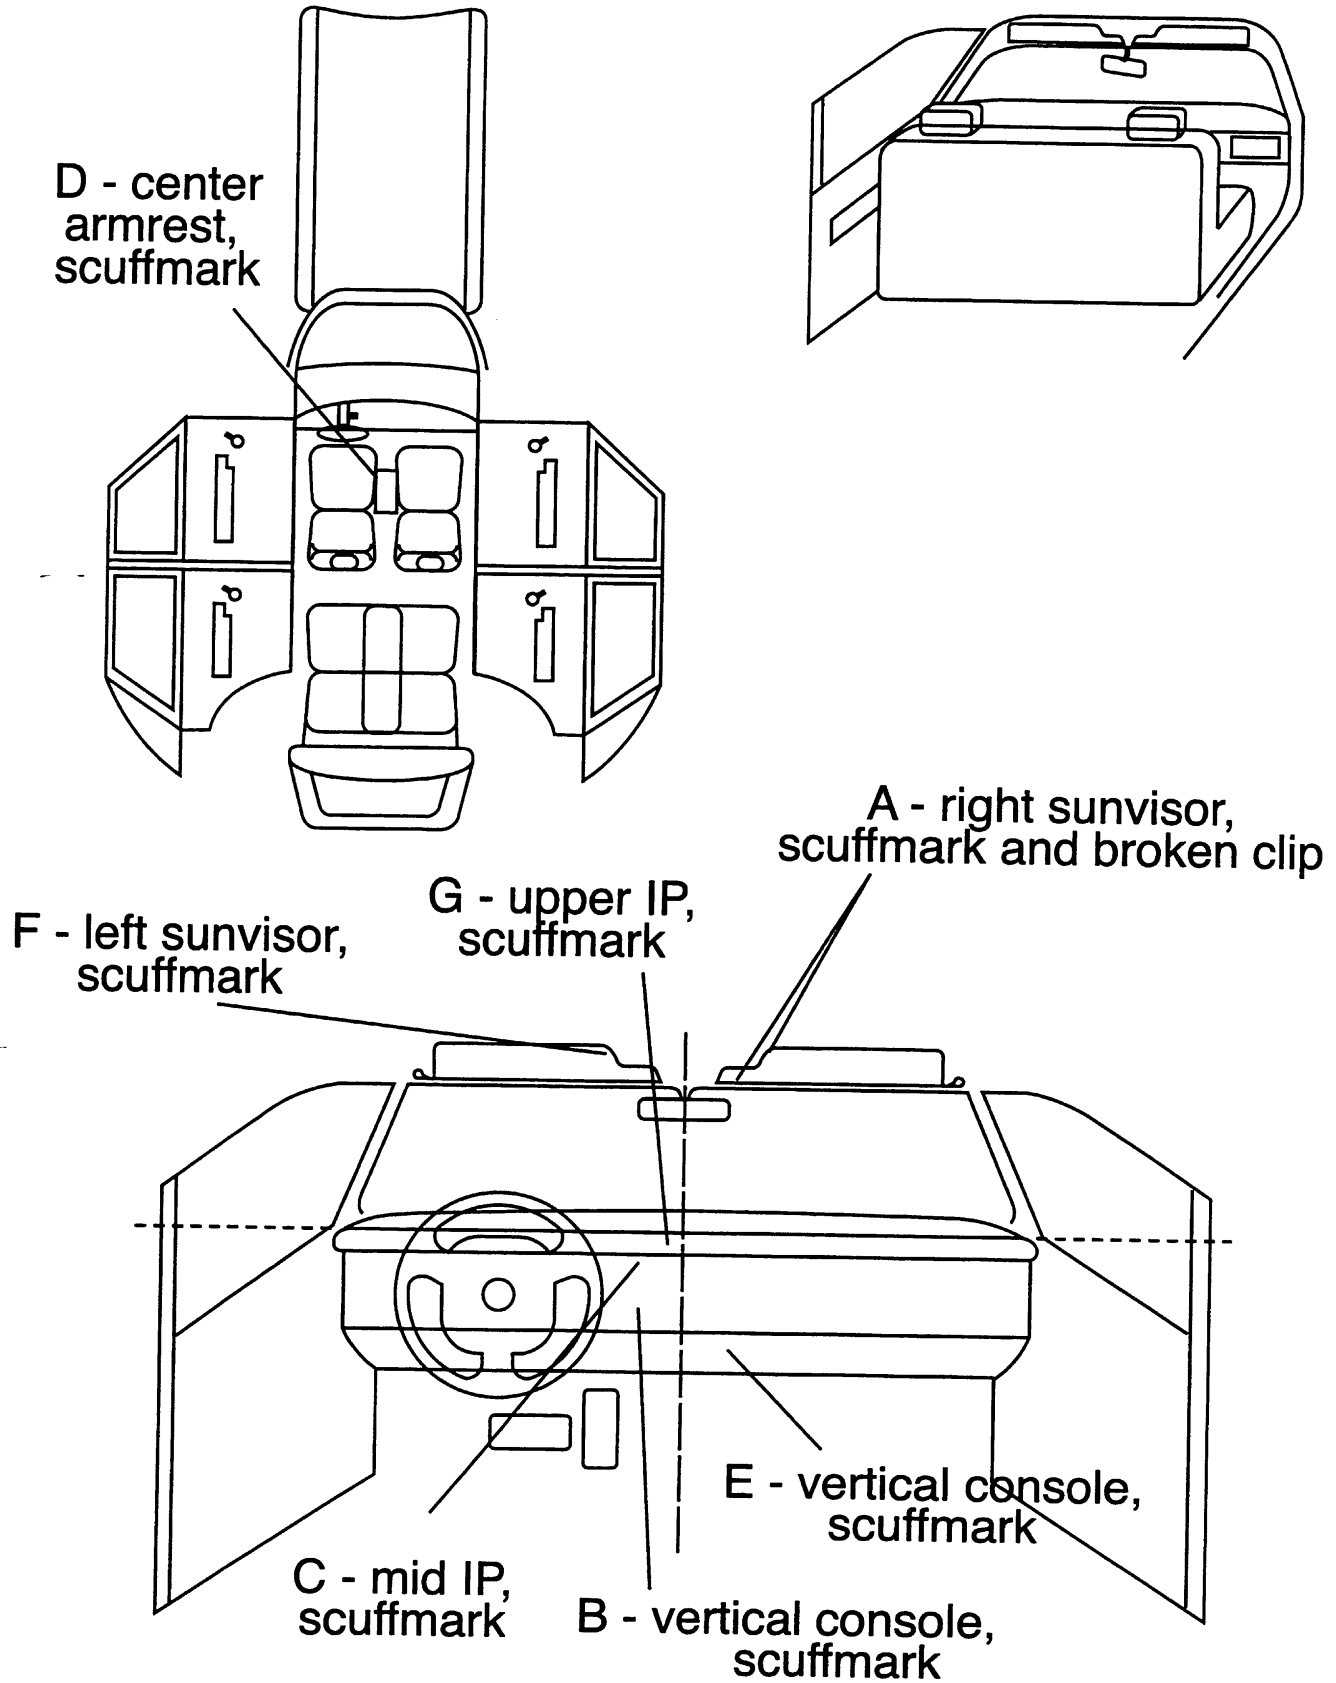
VEHICLE OCCUPANT CONTACT DIAGRAM

On impact, the driver moved to the right and forward relative to the vehicle interior. His direction of travel is indicated by the scuff marks on the (slide 51) center armrest/console, (slide 52) the vertical console, (slide 53) the twelve-volt plug-in receptacle, (slide 54) the mid instrument panel, (slide 55) the upper instrument panel, (slide 56) the left sunvisor, and (slide 57) the right sunvisor. He sustained a contusion to his head and a laceration above his right eyebrow, probably due to contact with the right sunvisor clip, as evidenced by the broken plastic clip and a scuff mark. He sustained abrasions to his right eyelid and chin, probably from contact by the driver airbag. He sustained an abrasion to his left knee, probably due to contact with the vertical console, as evidenced by a scuff mark.

Contact	Interior Component Contacted	Occupant No. if Known	Body Region if Known	Supporting Physical Evidence	Confidence Level of Contact Point
A	Rt. sunvisor	Driver	Head	Scuffmark and broken plastic	1
B	Vertical console	Driver	Lower extremity	Scuffmark	1
C	Mid instrument panel	Driver	Lower extremity	Scuffmark	1
D	Center armrest/console	Driver	Right side	Scuffmark	1
E	Vertical console	Driver	Lower extremity	Scuffmark	1
F	Lt. sunvisor	Driver	Head	Scuffmark	1
G	Upper Instrument panel	Driver	Upper extremity	Scuffmark	1

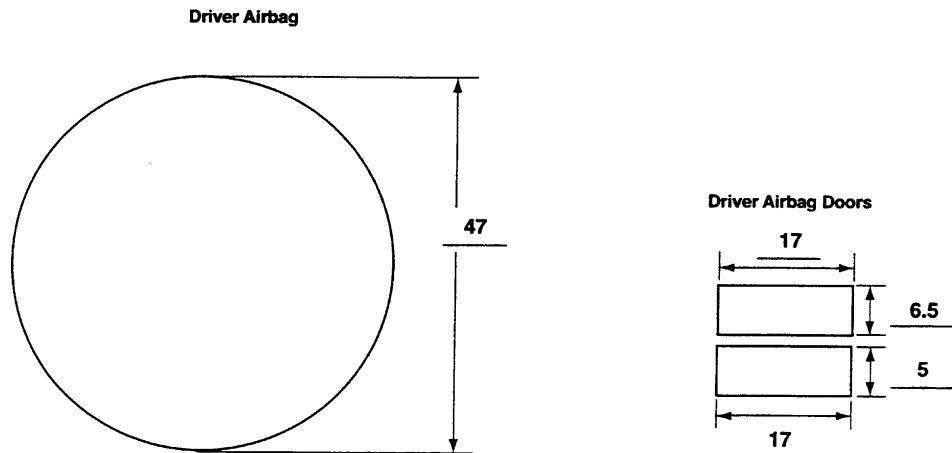
AIRBAG NUMBER ON DRIVER SIDE:

Vents: ☒ Y ☐ N  
if yes, how many: 2

Tethers: ☒ Y ☐ N  
if yes, how many: 2

at 11 and 1 o'clock

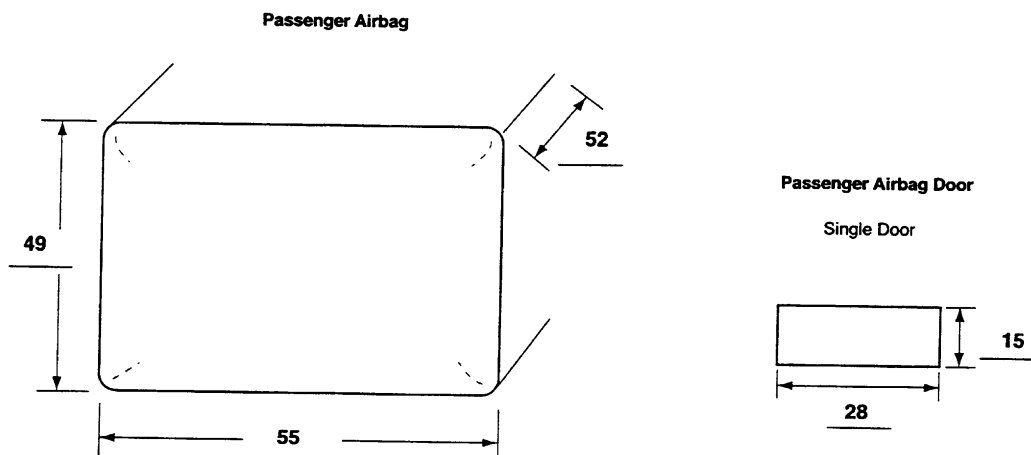
AIRBAG NUMBER ON PASSENGER SIDE:

Vents: Y ☒ N  
if yes, how many: \_\_\_\_\_

Tethers: ☒ Y ☐ N  
if yes, how many: 2

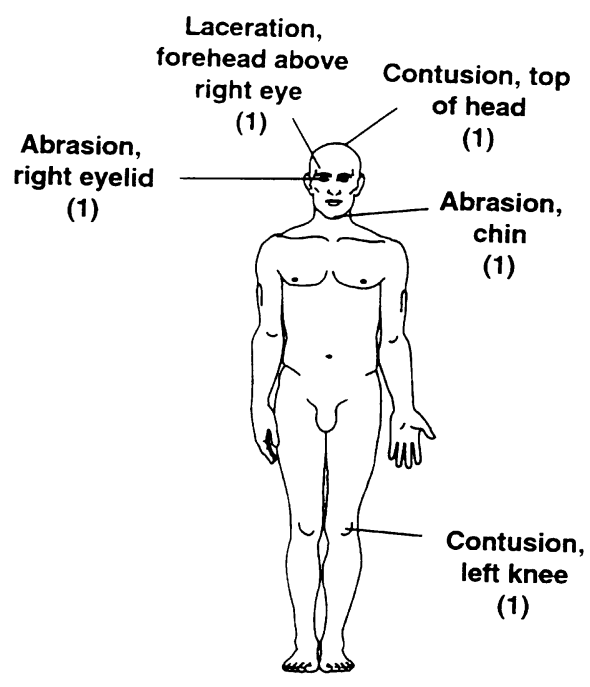
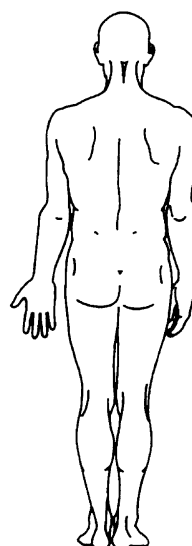
INDICATE LOCATION OF INJURIES.

Injury Description	A.I.S.	Injury Source		
		Definite	Probable	Possible
Contusion, top of head	1		Right sunvisor	
Laceration, forehead above right eye	1		Right sunvisor	
Abrasion, right eyelid	1		Airbag	
Abrasion, chin	1		Airbag	
Contusion, left knee	1		Vertical console	
<u>Maximum A.I.S. Level</u>	<u>1</u>			
<u>Injury Severity Score</u>	<u>1</u>

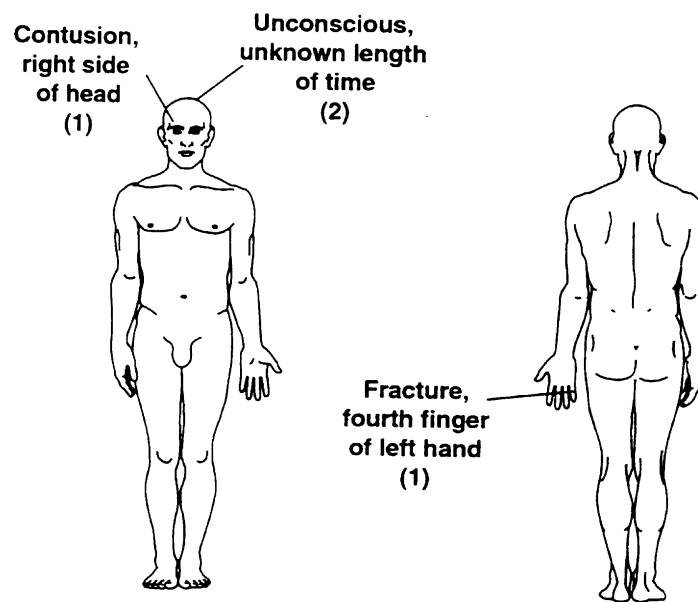
INDICATE LOCATION OF INJURIES.

Injury Description	A.I.S.	Injury Source		
		Definite	Probable	Possible
Contusion, right side of head	1		Roof siderail/A-pillar	
Unconscious, unknown length of time	2		Roof siderail/A-pillar	
Fracture, fourth finger of left hand	1		Driver	Airbag
<u>Maximum A.I.S. Level</u>	<u>2</u>			
<u>Injury Severity Score</u>	<u>6</u>
